ASBESTOS INSPECTION DIAGRAM
 PROJECT #4207-04 (4800 South 1st Street)
 200 WING - WINDOW & PIPING DIAGRAM

Project Location: 4800 S. Commercial Structure, 4800 South 1st Street, Austin, Texas

Date: 11/15/04

Page: 2 of 4

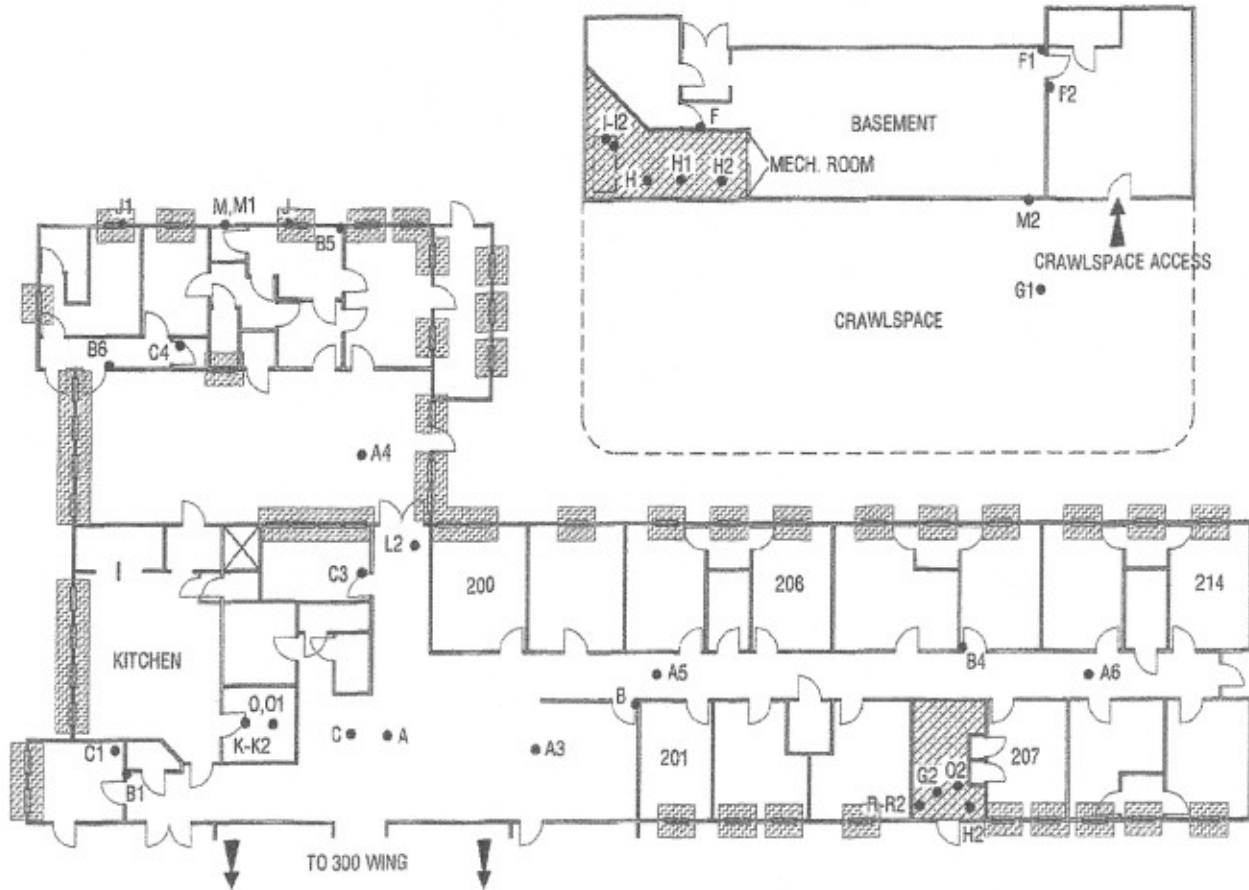
NOTE: ACM Hardpack TSI on Pipe Fittings is Throughout Mechanical Rooms & Assumed Throughout Building

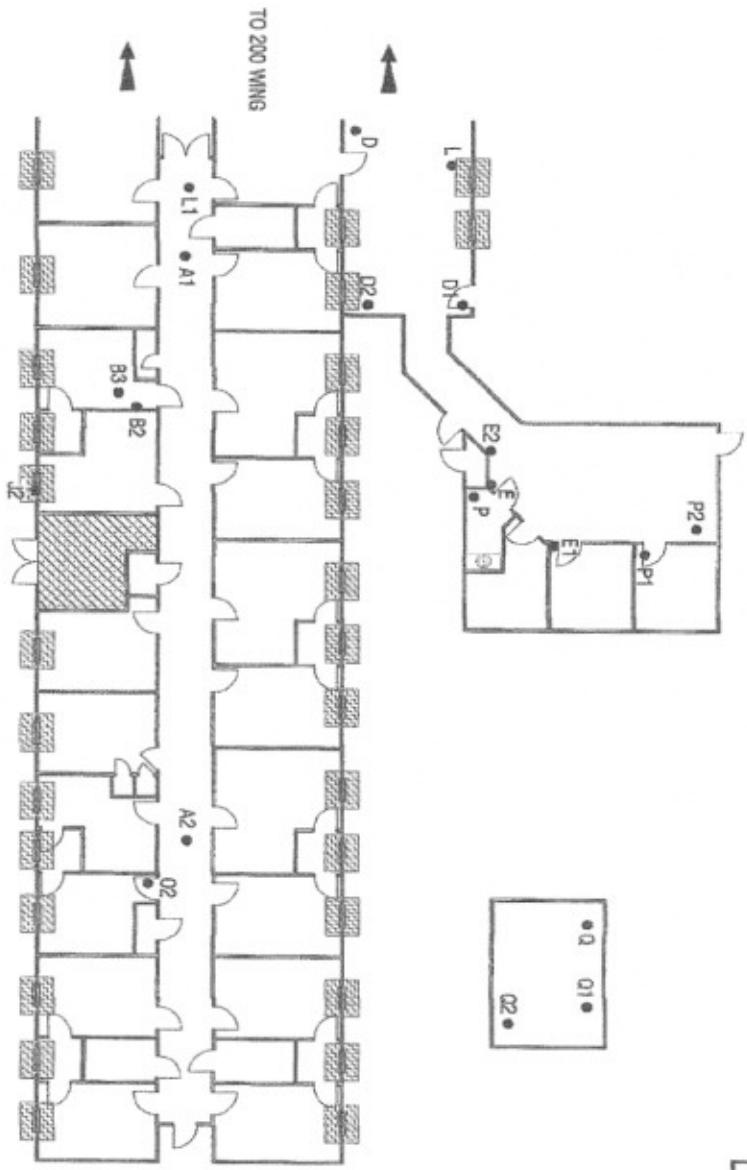
ASBESTOS INSPECTION DIAGRAM
 PROJECT #4207-04 (4800 South 1st Street)
 300 WING - WINDOW & PIPING DIAGRAM

NOTE: ACM Hardware TS on Pipe fittings is throughout Mechanical Rooms & Assumed Throughout Building
